### Science and Art: A Future for Stone

**Proceedings of the 13<sup>th</sup> International Congress on the  
Deterioration and Conservation of Stone – Volume II**

6<sup>th</sup> to 10<sup>th</sup> September 2016, Paisley, Scotland

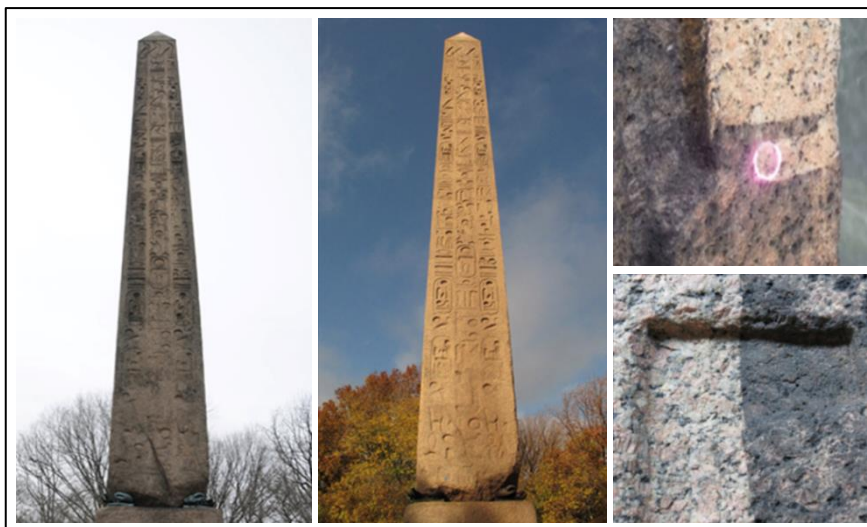
*Fig. 8: Overall and detailed results of laser cleaning the obelisk.*

The granite surface was examined with a portable USB microscope during treatment to ensure that no damage was being done to the surface. Photomicrographs were taken to document the cleaning results. Fig. 9 shows a one area before and after laser cleaning in regular light and infrared light. IR light helps show carbon on a surface. The images show that the soiling was successfully removed and that the black biotite inclusions, pink quartz, white quartz, and other minerals were not damaged during the cleaning process. In fact, the green arrows point to two small grains of quartz on the surface which are not disrupted at all by the cleaning process and remain intact.

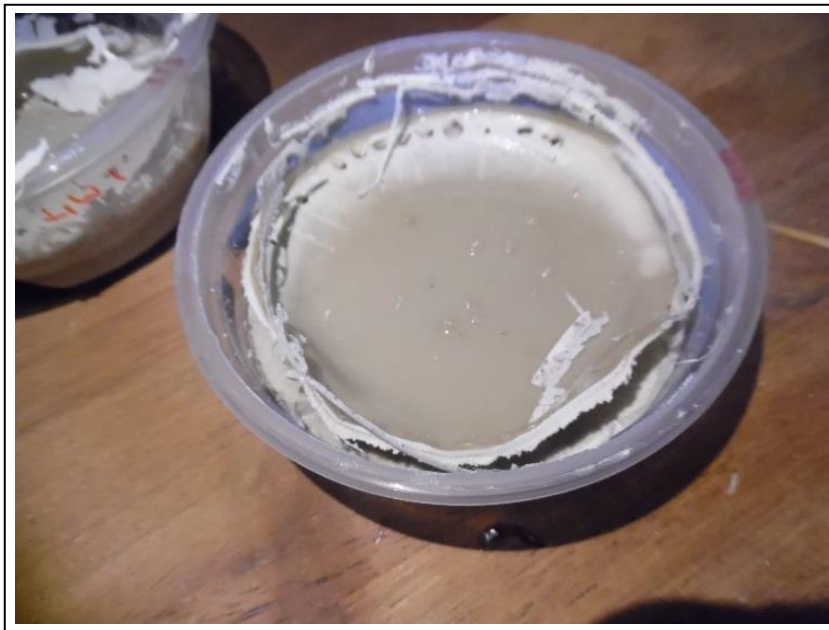
*Fig. 3: Excessive shrinkage from the 100:55 quartz flour : lithium silicate formulation when poured into an open impervious cup. This result led to the alternative test methods relying on more replicative applications to vertically oriented cavities.*

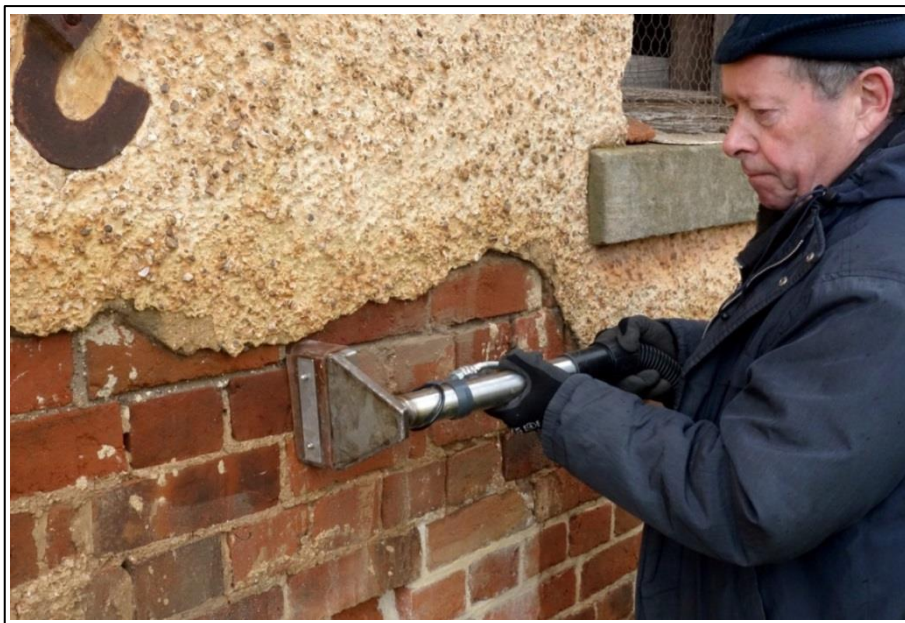
*Fig. 1: Captive-head washing system being used by Walter Heim to remove dust and dirt from brickwork prior to render repairs at Brickendon, Longford, Tasmania.*

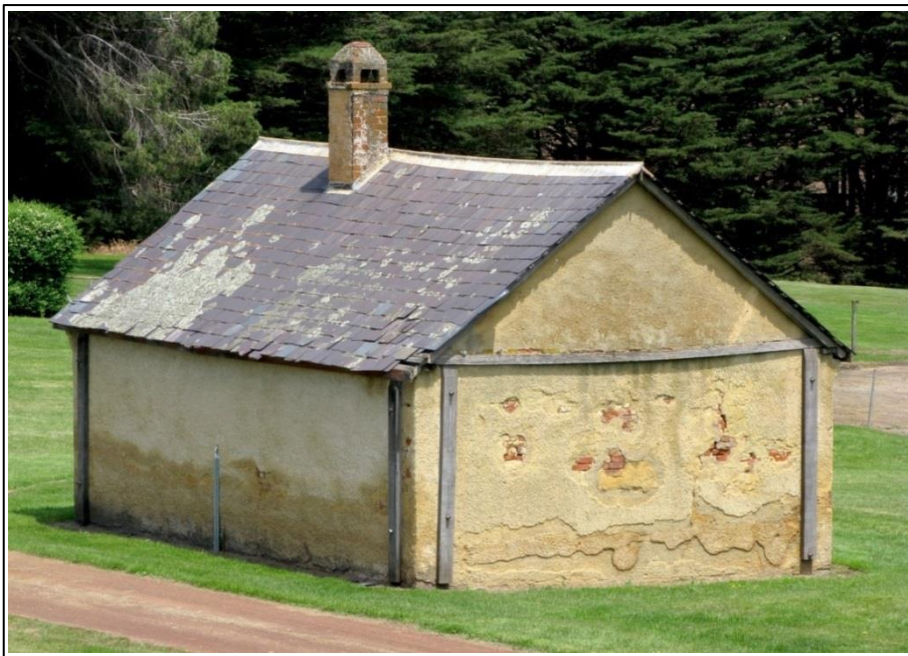
*Fig. 2: Woolmers Estate blacksmith's shop from the north. Failed rendering (harling) on the northwest wall (to the right) is allowing penetrating dampness to carry salts through the 350 mm brickwork to the interior (see Figure 3).*

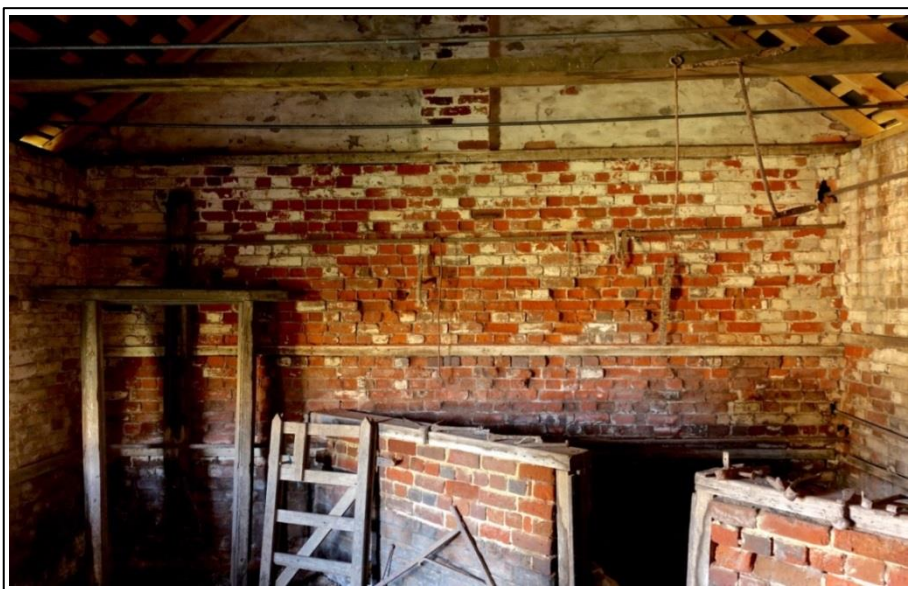
*Figure 3: Interior of northwest wall showing extensive decay of low-fired bricks due to salt attack. Early limewash finishes remain on undamaged parts of the wall.*

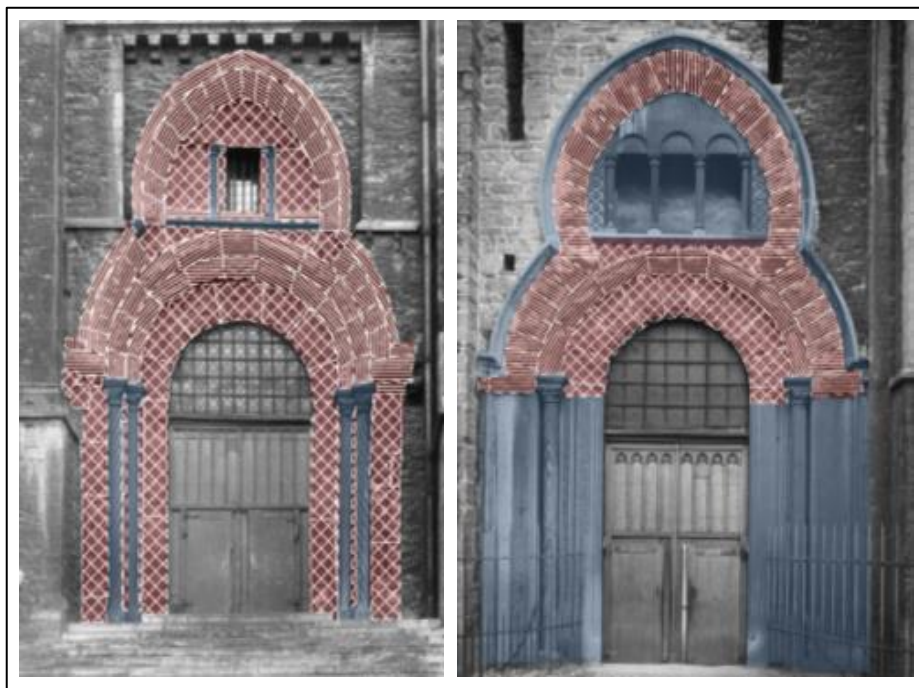
*Fig. 3: Mapping of the bedding planes of the original stone blocks in the Mantile (left) and Capitole portal (right). Hatchings underlines the bedding planes, while crosshatching is used for face-bedded blocks. Blue-coloured zones correspond to the 19th century restoration with Belgian bluestone ©KIK-IRPA, Brussels.*

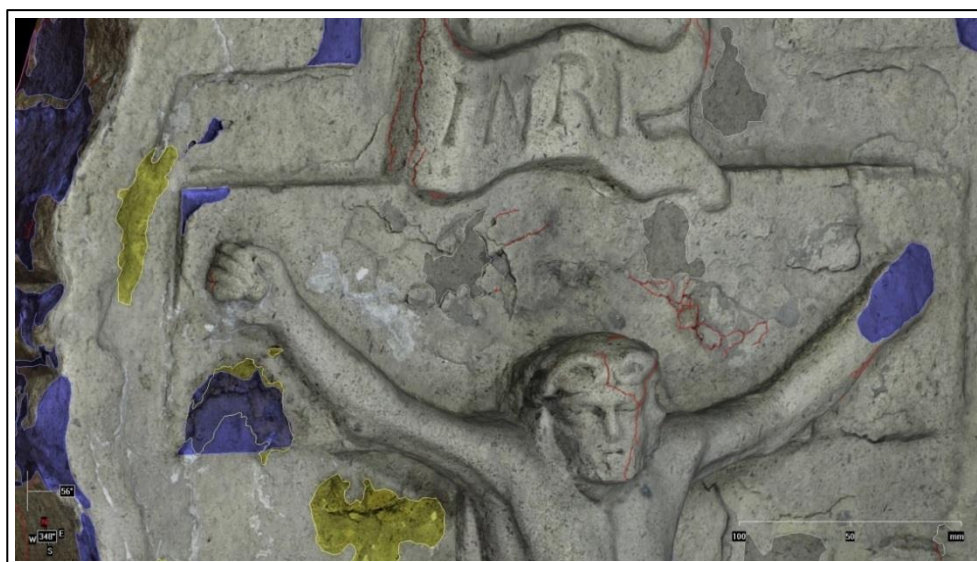
*Fig. 7: 3D monument damage mapping of late baroque tombstone: Detail.*

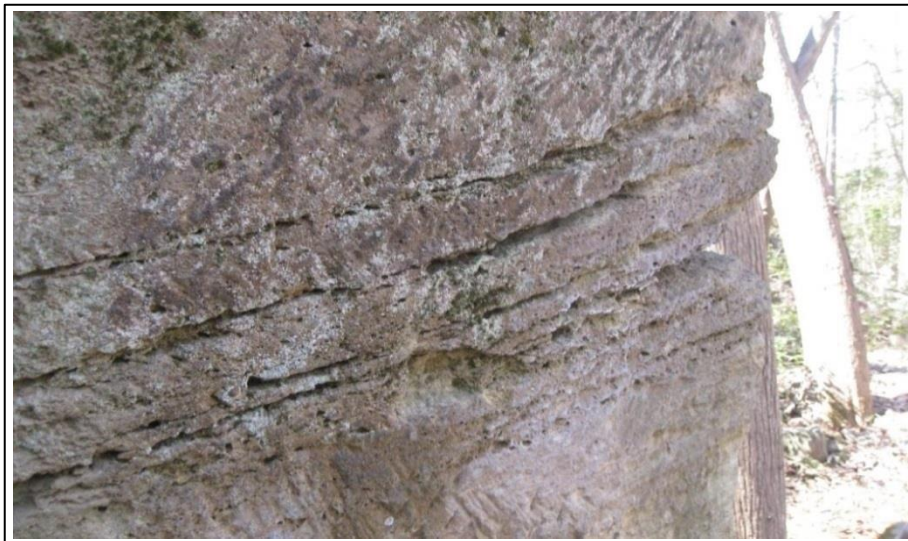
*Fig. 2: Quarry face on Government Island, a state park where Aquia Creek sandstone was once quarried, with horizontal voids indicating stone unsuitable for buildings (2013).*

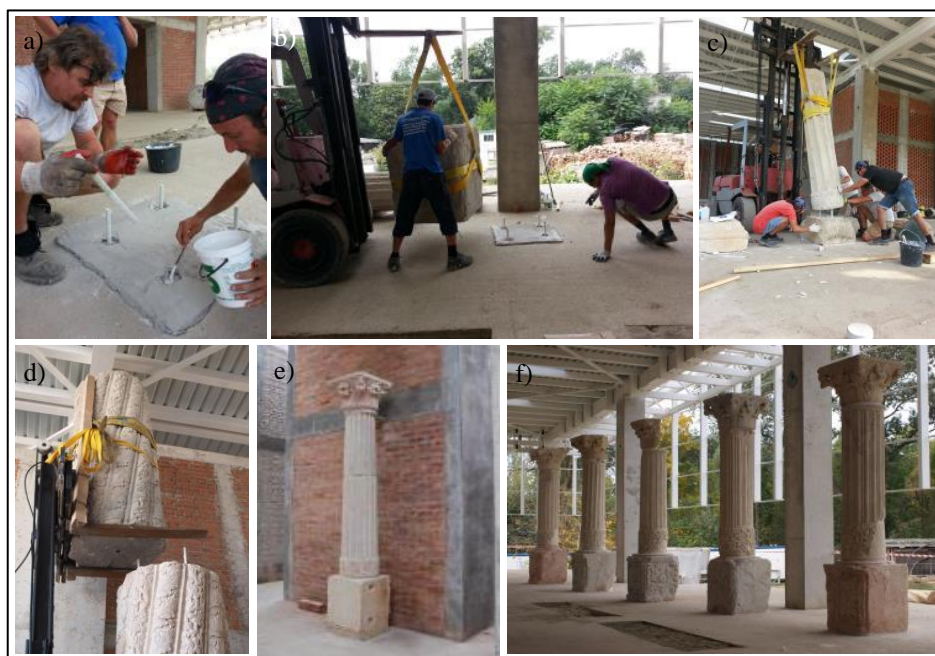
*Fig. 5: Installation of the columns: a and b) Bottom pin structure, c to e) Assembly of the decorated stone block to columns in the Royal House; f) Columns of the veranda.*
